Evaluation of the Ateco "RIP-PACKER"

EVALUATION OF THE ATECO "RIP-PACKER"
ED&T 1669

Edward Stuart III, Civil Engineer
Engineering Materials Investigation Branch

Equipment Development and Test Report 7700-3
Forest Service
U.S. Department of Agriculture
July 1970

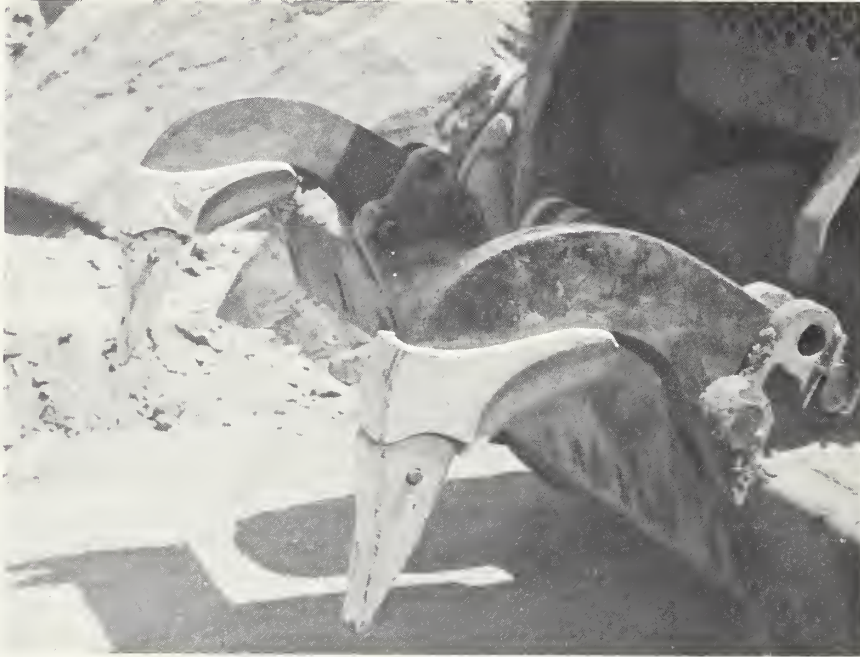
Figure 1. The mounted ripper assembly portion of the ATECO equipment

The assembly consists of a tool beam that accommodates five ripper teeth. The center-to-center distance of the teeth is 0.53 meters (21 inches), for a total ripping width of 2.13 meters (84 inches). The ripper teeth are removable and can be used in any combination up to five. The teeth are of the curved type and are capable of providing ripping depths to 0.48 meters (19 inches). The assembly was hydraulically operated and mounted on the rear of the Caterpillar Tractor Company's motor grader model CAT-12E.

The ripper assembly used in this study was ATECO's Model HR-12 (fig. 1).

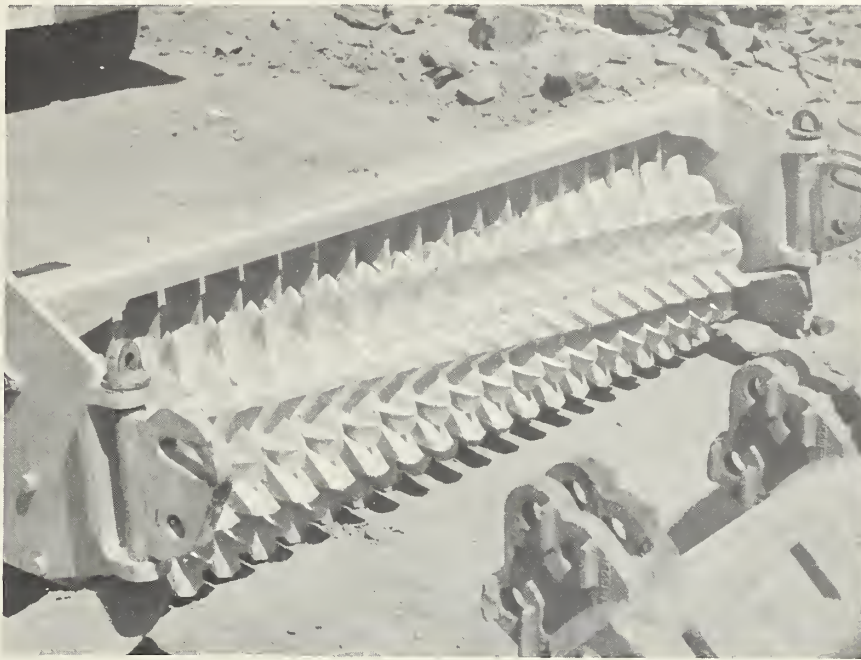
Figure 2. The compaction-cutter-crusher unit portion of the ATECO equipment. The large brackets at either end of the unit are pinned to the tool beam.

The CCC is designed to mount on the tool beam in place of the ripper teeth. It can be worked in both forward and reverse directions, eliminating the requirement for turning the equipment around. The unit's overall length is 2.36 meters (93 inches) and works a 1.83-meter (6-foot) swath of roadway section. The overall depth is 0.84 meters (33 inches) and the overall height, 0.84 meters. The unit weighs 11.57 kilonewtons (2,600 pounds).

The CCC unit used in this test was ATECO's Model CCC-619, Mark II (fig. 2). This model replaced the CCC-6 model ^{1/} used in the SDEDC's preliminary evaluation. The only apparent major difference between the old and new models is the number of cutter rings; the CCC-6 had 17, while the new Mark II has 19. Each of

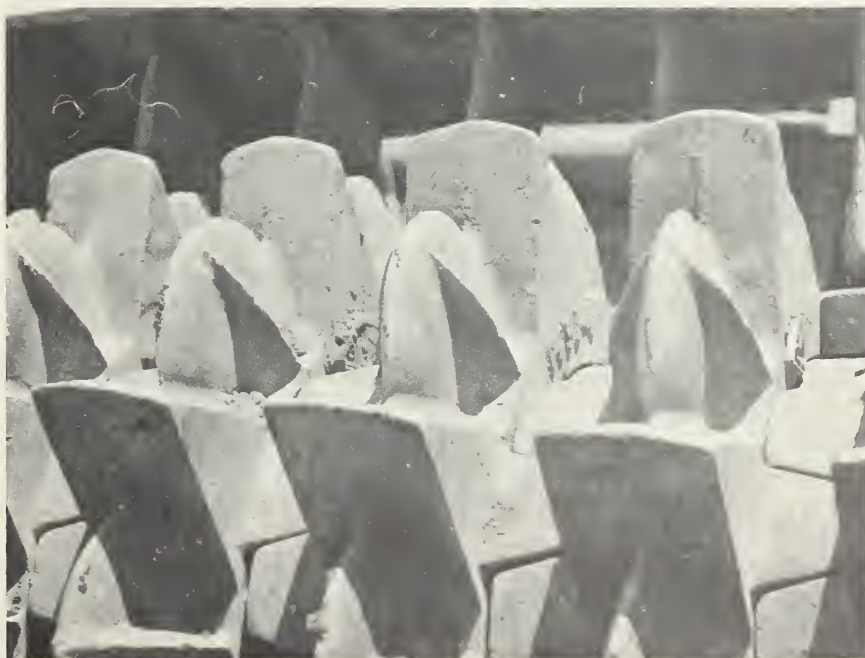
the rings is 0.53 meters (21 inches) in diameter; has eight circular longitudinal cutters for scoring and splitting, plus diagonal crusher teeth for crushing, sizing, and compacting; and is made of hard, heat-treated alloy steel (fig. 3).

Figure 3. A close-up of the cutter rings of the CCC unit.

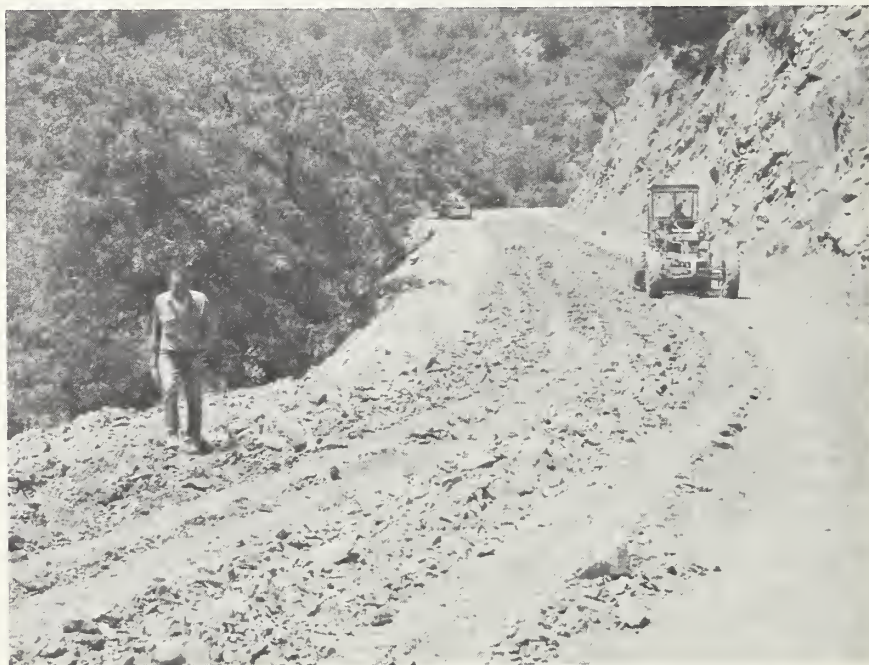
The field test began in June, 1968, and initially proceeded as outlined in the test plan. The Cottonwood Road on the Stanislaus National Forest was the first one tested. The material on this road consisted primarily of schist with a LART value of 34.4, and there were outcroppings of rock up to 300 mm (12 inches) in diameter. The section of road tested had a grade averaging approximately 5 percent, was 396 meters ($\frac{1}{4}$ mile) long and 6.0 meters (20 feet) wide. Half the road (198 meters or $\frac{1}{8}$ mile) was watered, and the remaining half was left in its natural moisture condition. The entire section was ripped by using two ripper teeth, and rocks having diameters larger than 250 mm (10 inches) were side-cast by using the blade (fig. 4).

Figure 4. Ripping operations on the Cottonwood Road

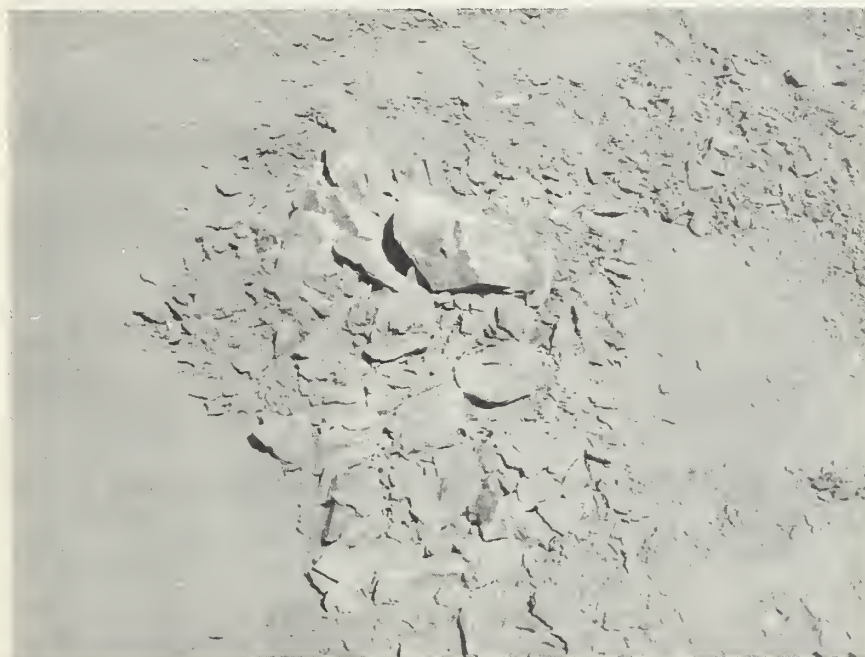
Sixteen passes were made with the ripper. The CCC unit was then mounted on the motor grader and 16 passes were made with this unit (fig. 5). Samples of material were taken after each series of four passes. It was noted during the test, however, that there was very little improvement after the first eight passes. The final opera-

Figure 5. A small pile of rocks broken after the first pass of the CCC unit on the Cottonwood Road

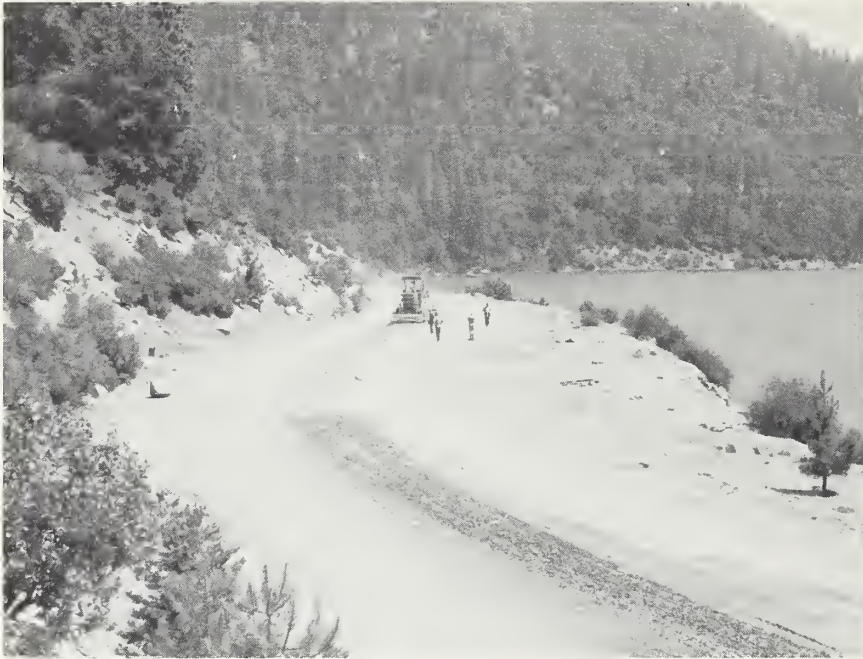
was from the old ballast material. The road, for the most part, was level and approximately 6.1 to 7.6 meters (20 to 25 feet) wide; however, only a 3.0-meter (10-foot) wide section of the road was worked by the Rip-Packer (fig. 6).

Figure 6. CCC operations on the Beardsley Road

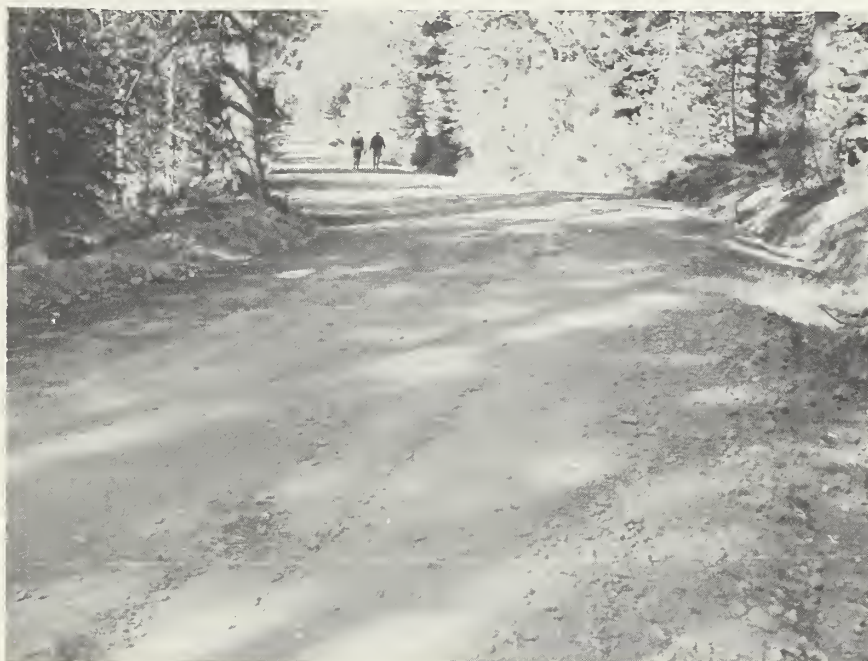
The third road, the Texas Hill Road on the Tahoe National Forest, contained a mixture of volcanic and granitic rock of the river-run variety. The material, as shown in Table 1, was somewhat harder (LART value of 12.0) than the material in the two previous roads tested. The Texas Hill Road was essentially flat, with a few large radius curves (fig. 7). The surface consisted of a considerable amount of small 76-mm (3-inch) diameter rock, with many outcroppings of larger rock.

Figure 7. The original surface of the Texas Hill Road

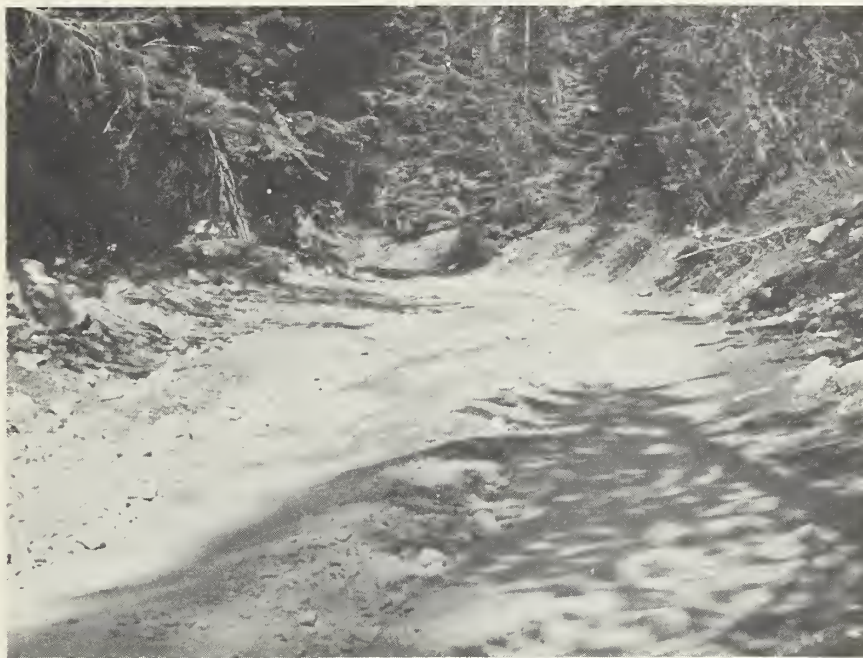
510-mm (18 to 20 inches) in diameter, with the majority being in the 100- to 200-mm (4- to 8-inch) range (fig. 9).

Figure 9. The original surface of the Fordyce Road

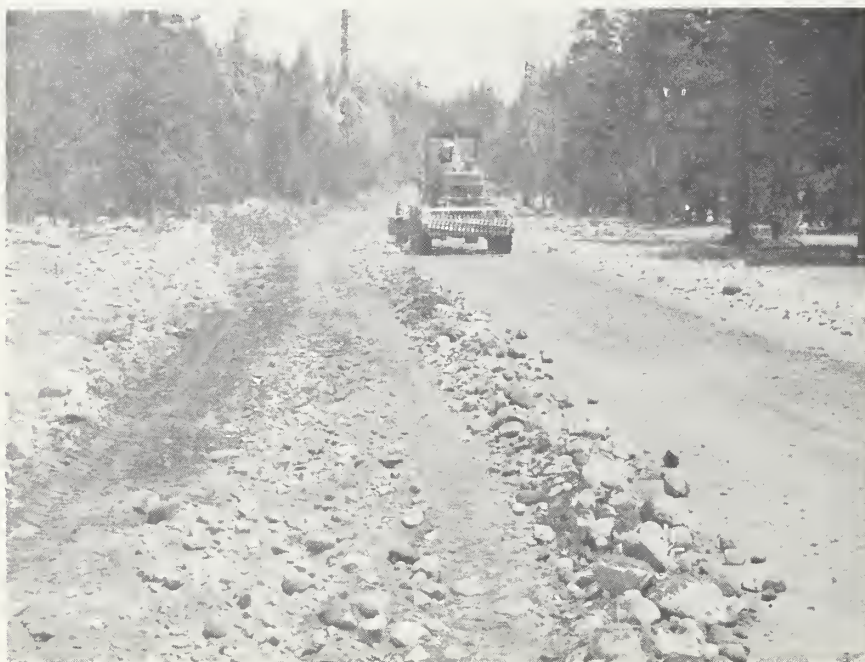
The last site tested, also on the Tahoe National Forest, was the Magonigal Road. This was very similar to the previous road except that it contained more volcanic than granitic material. Because of the inability of the CCC unit to break or crush similar rock on the two previous sites in this general area, it was decided that, prior to ripping this section, some preliminary testing would be performed. First, rocks from the large roadway berms were bladed onto a hard-packed, undisturbed section of roadway. After several passes were made with the CCC unit and only a minor amount of material had broken up, the rock was again bladed onto a firm base in a controlled windrow; and further processing was attempted (fig. 10).

Figure 10. Surface rock being worked into a windrow on the Magonigal Road

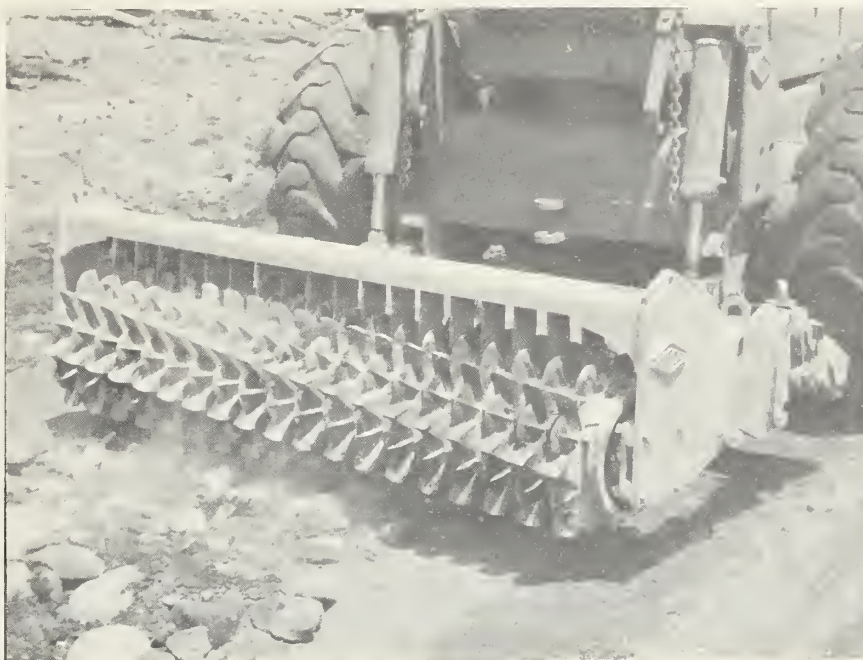
After completion of 18 passes by the CCC unit, it was obvious that rock on this roadway could not be broken or crushed under ideal conditions — controlled windrows, firm base for impact, etc. — and that further testing of this section as previously planned would prove to be wasted (fig. 11).

Figure 11. Results of processing the windrows on the Magonigal Road with the CCC unit. Note the lack of visible rock breakage.

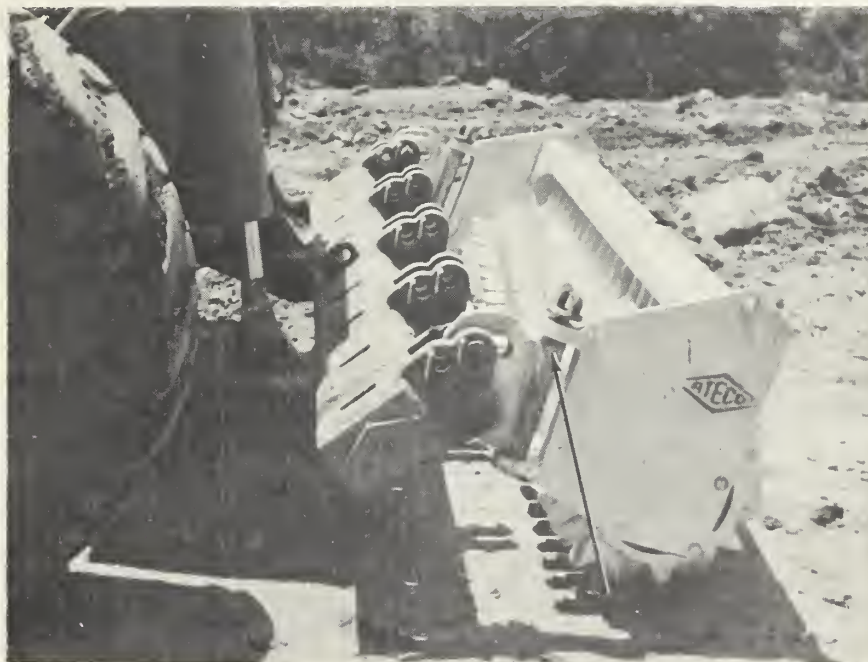
The long pins that attach the CCC to the ripper bar (fig. 12) worked out of their sockets several times. They are presently retained in place by a cotter pin which has a tendency to fall out and get lost. A better pin-retaining device should be developed. San Bernardino National Forest personnel who operate several ATECO units have developed a method for locking the pins which they consider greatly superior to ATECO's method (fig. 13).

Figure 12. ATECO's attachment method

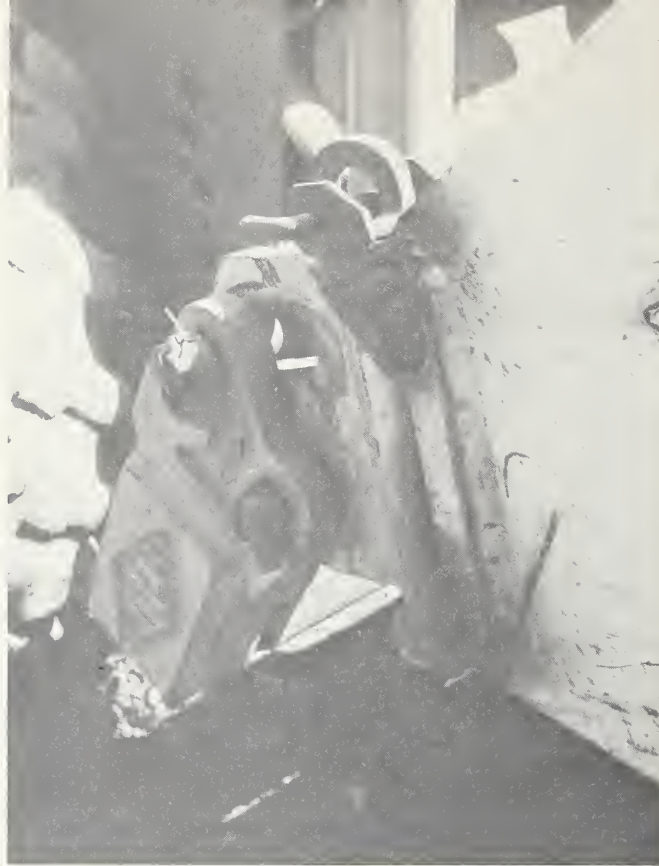
Figure 13. Improved attachment method

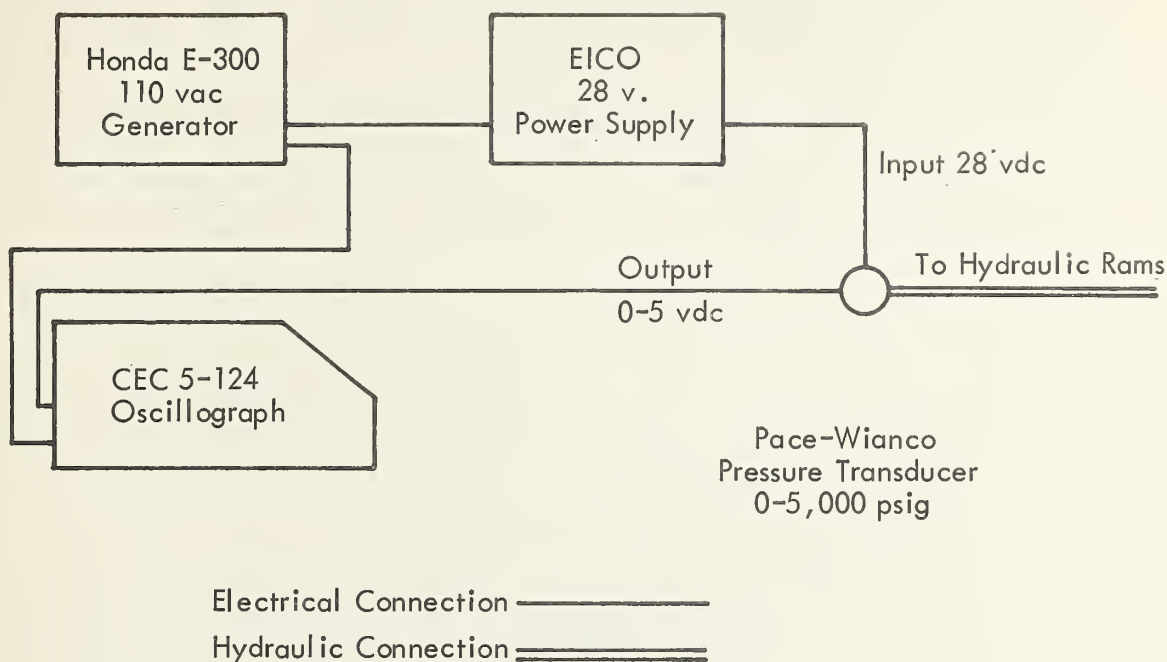
The hydraulic pressure in the rams that activate the Rip-Packer was monitored for some of the tests, using the instrumentation system shown in Figure 14. The heart of this system is a Pace-Wianco type P2 3086 pressure transducer. The hydraulic connection of this pressure transducer was fed into the line which supplies hydraulic fluid to the main rams. The transducer's input was provided by an Eico 28-volt power supply, which was in turn supplied by a Honda E300 110-volt AC generator. The output of the transducer was fed to a CEC type 5-124 light beam oscillograph. This instrument provides almost immediate response to any transient signals; thus, abrupt peaks in hydraulic pressure were easily recorded. The oscillograph, too, was powered by the Honda generator. This instrumentation system provided a continuous record of pressure in the hydraulic system during a given run.

Figure 14. Instrumentation system

The pressure at the inlet of the rather long hydraulic hose which supplies the hydraulic rams with fluid might not have faithfully followed the pressure in the rams. However, since the intent of this experiment was to determine the relative magnitude of pressure surges in the hydraulic system under different operating conditions, this was not thought to be a serious limitation.

Table 4 summarizes the data. Note that, with the hydraulic accumulator valve open, the rapid pressure variation due to the CCC striking rocks was approximately 1,000 psi (peak to peak) and in no case exceeded pressures normally encountered during blading and ripping. With the accumulator valve closed, the maximum pressure variation went as high as 2,600 psi. It is suggested, therefore, that during CCC operations the hydraulic accumulator valve be left open, since no increase in effectiveness of rock-breaking was observed when this valve was closed.
